Accurate Home & Building Inspection Services, LLC

CONFIDENTIAL INSPECTION REPORT

123 Orange Street, Sunshine, North Carolina 12345

9/20/2013

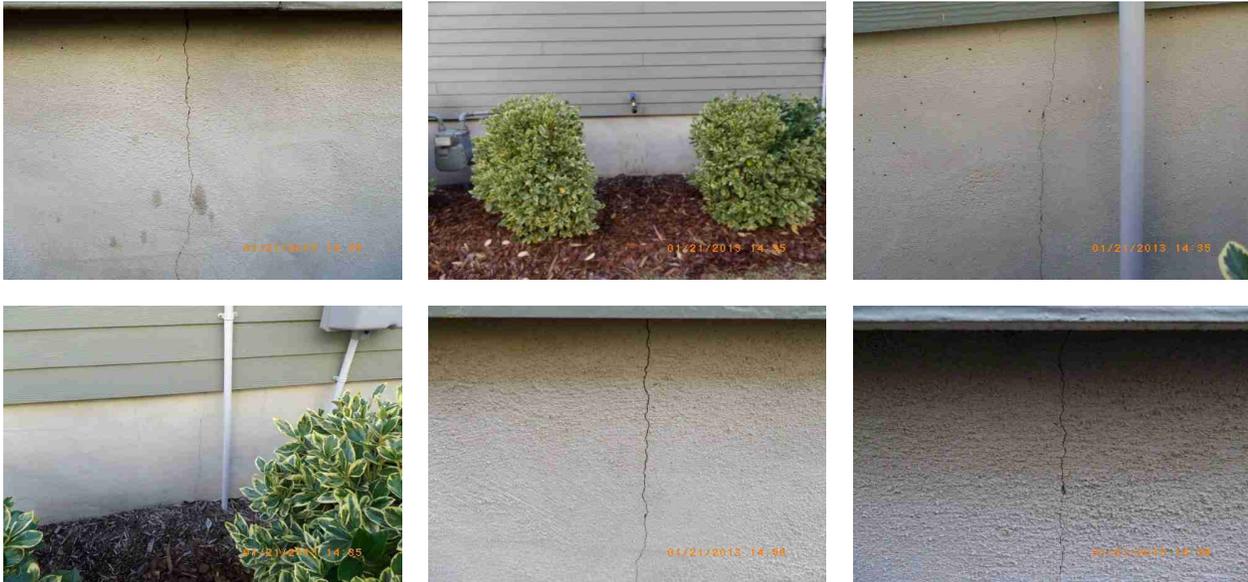
2.1 - The foundation walls consist of concrete block and a cement based skim coat on the exterior walls. It is not uncommon to find cracks in the skim coat. These do not have any structural concern, but should be sealed to prevent moisture intrusion and further cracking.

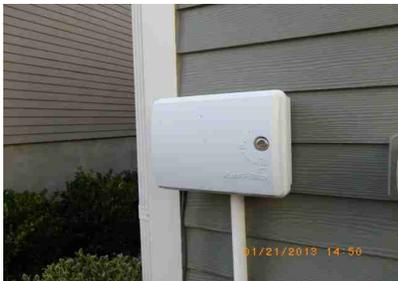
5.1 - We did not evaluate the sprinkler system, which should be demonstrated by the sellers to be functional.

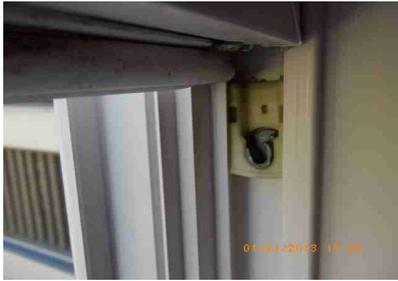
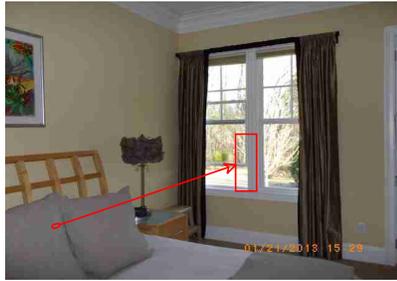
Rear master bedroom window - *Continued*

9.1 - The right side of the rear left lower master bedroom window is detached from the sash guide and should be repaired.

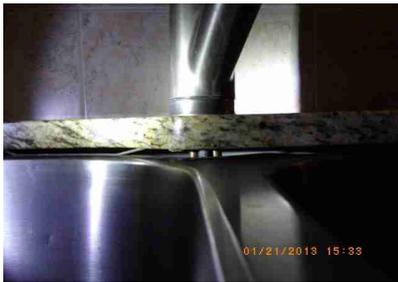
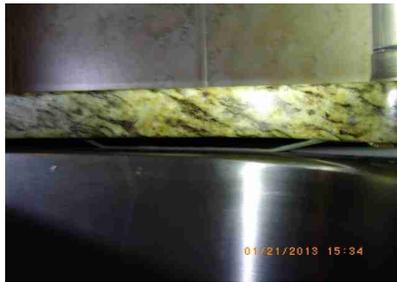
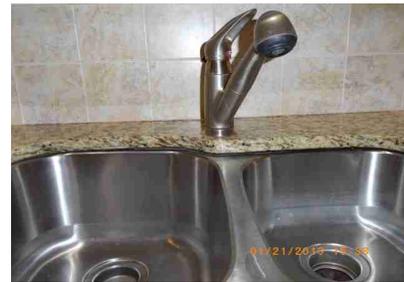
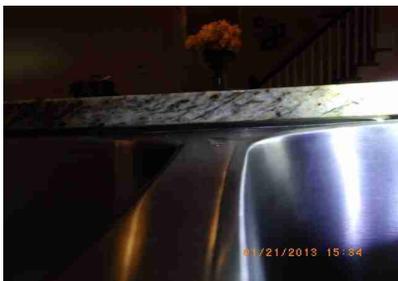
10.1 - The under counter sink is partially detached from the counter top. This can not only allow water to splash inside the cabinet, but the loose sink can loosen water connections which could lead to leaks. Recommend having a qualified professional repair and seal the sink to the counter.

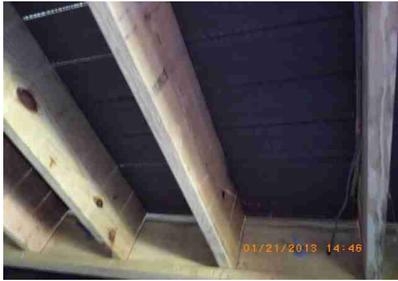
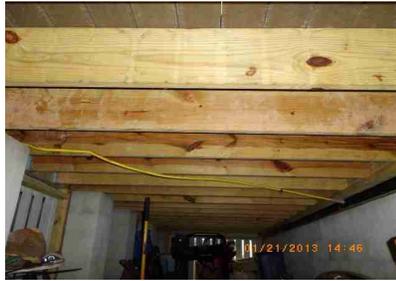
Screening of deck - *Continued*

12.1 - The rear deck has been screened to allow the users to enjoy the outside without being bothered or "pestered" by insects. The bottom of the deck however has not been screened. This will allow insects inside the screened area. Recommend having the bottom of the deck fully screened.

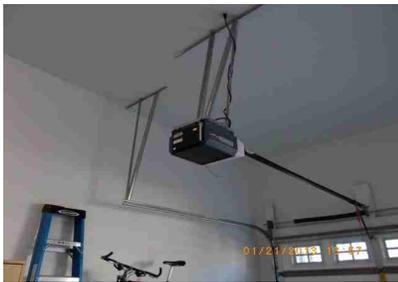
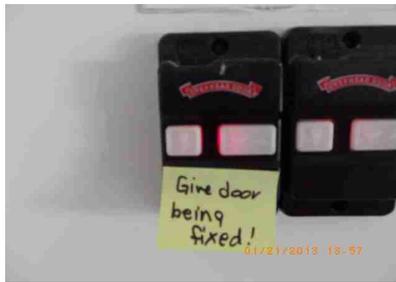
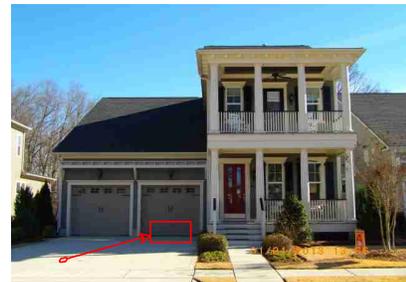
17.1 - The right garage door opener (front porch side) has been disconnected from the door. A note has been placed below the control button indicating the door is being fixed. The bottom panels of the door are damaged. Recommend having the seller's demonstrate that the door and both safety devices are functioning property once the door has been repaired.

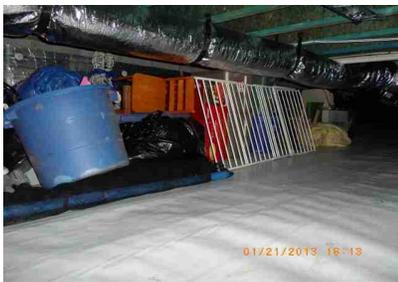
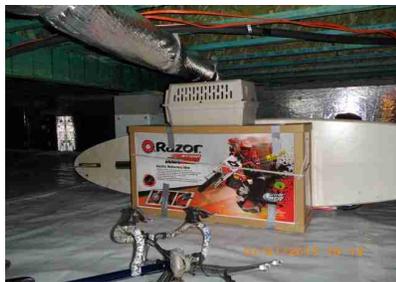
19.1 - Cellulose-based debris such as cardboard and/or paper from boxes were found in the crawl space. Recommend removing all cellulose-based debris to avoid attracting wood destroying organisms and accumulations of moisture.

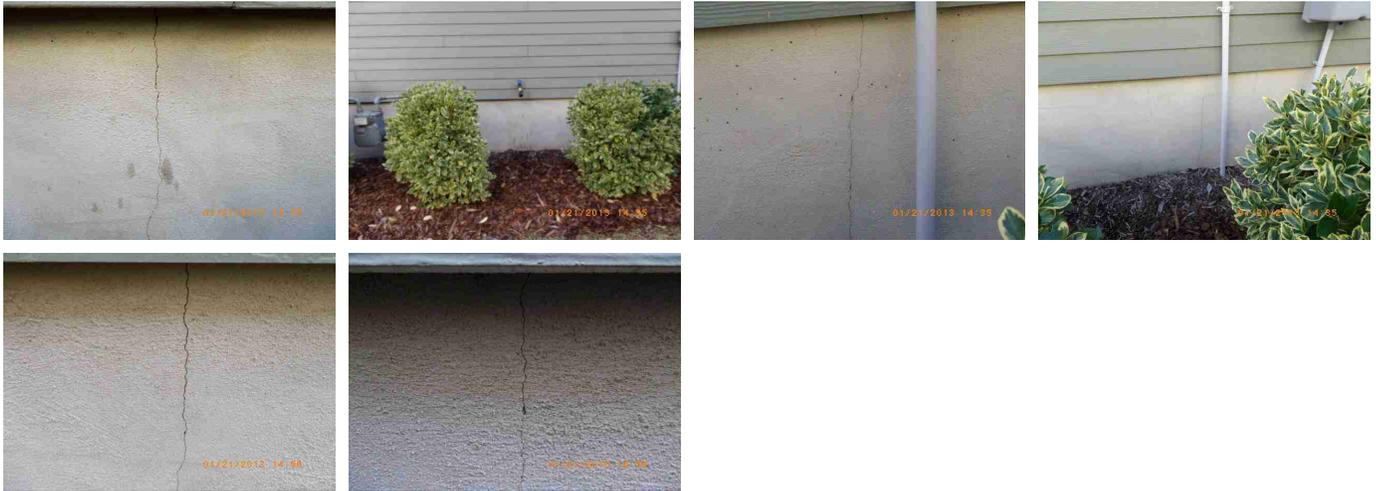
2.2 - The foundation walls consist of concrete block and a cement based skim coat on the exterior walls. It is not uncommon to find cracks in the skim coat. These do not have any structural concern, but should be sealed to prevent moisture intrusion and further cracking.

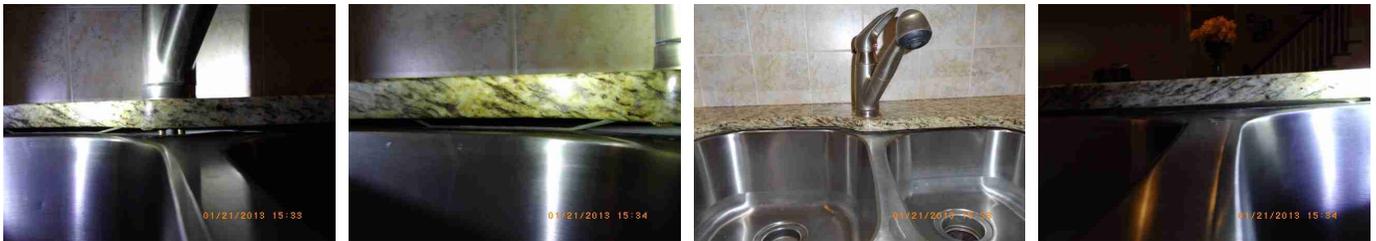
10.2 - The under counter sink is partially detached from the counter top. This can not only allow water to splash inside the cabinet, but the loose sink can loosen water connections which could lead to leaks. Recommend having a qualified professional repair and seal the sink to the counter.
